# THE SANTA BARBARA COUNTYWIDE PARTNERS IN RESTORATION PERMIT COORDINATION PROGRAM

## Sample Project Covered Under the Program

### Channel Stabilization

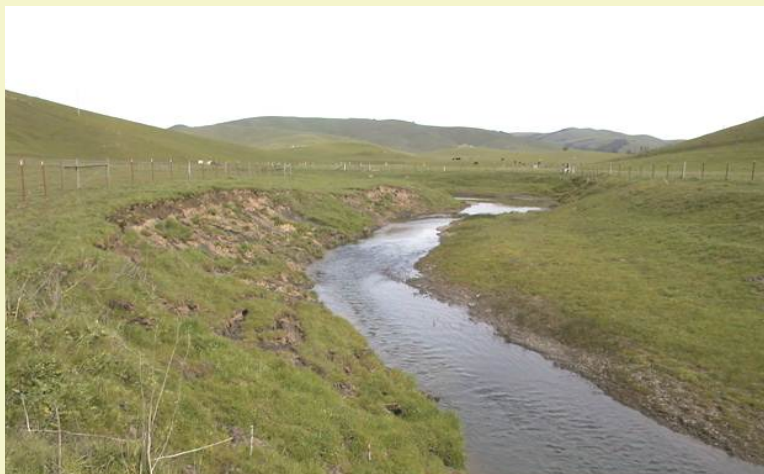
Unstable section of bank along stream

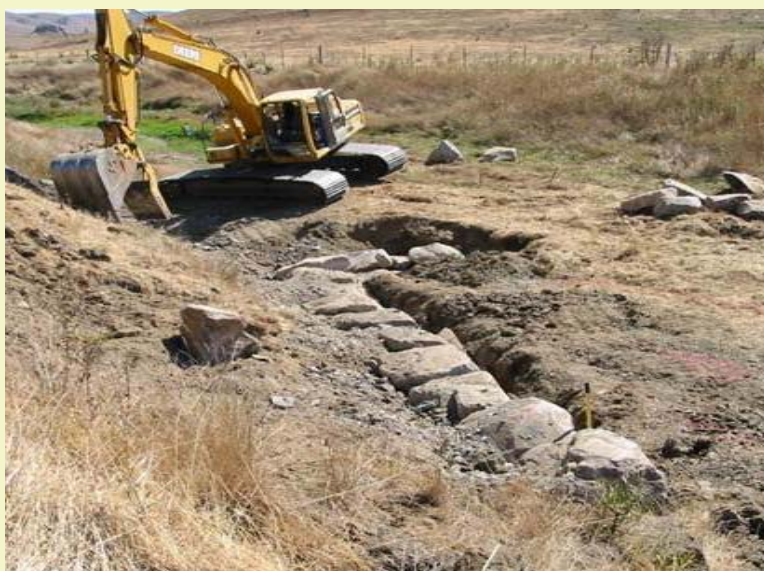
Rock J-hook under construction

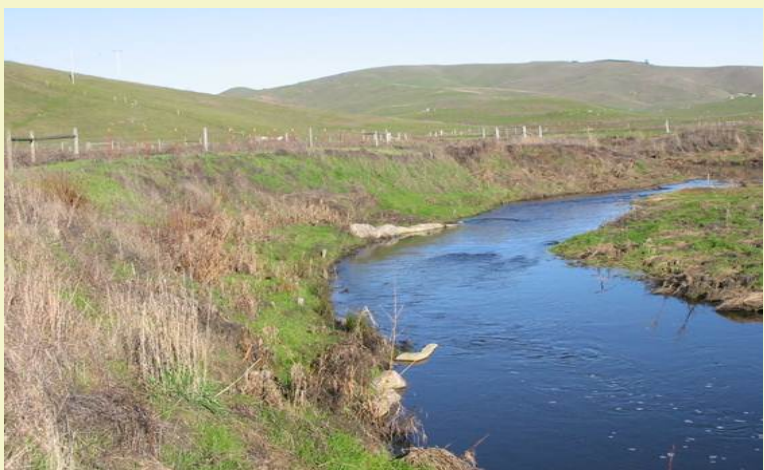
Streambank following construction and revegetation
